CR 91.006

April 1991

## Contract Report

## CAST COIL TRANSFORMER FIRE SUSCEPTIBILITY AND RELIABILITY STUDY

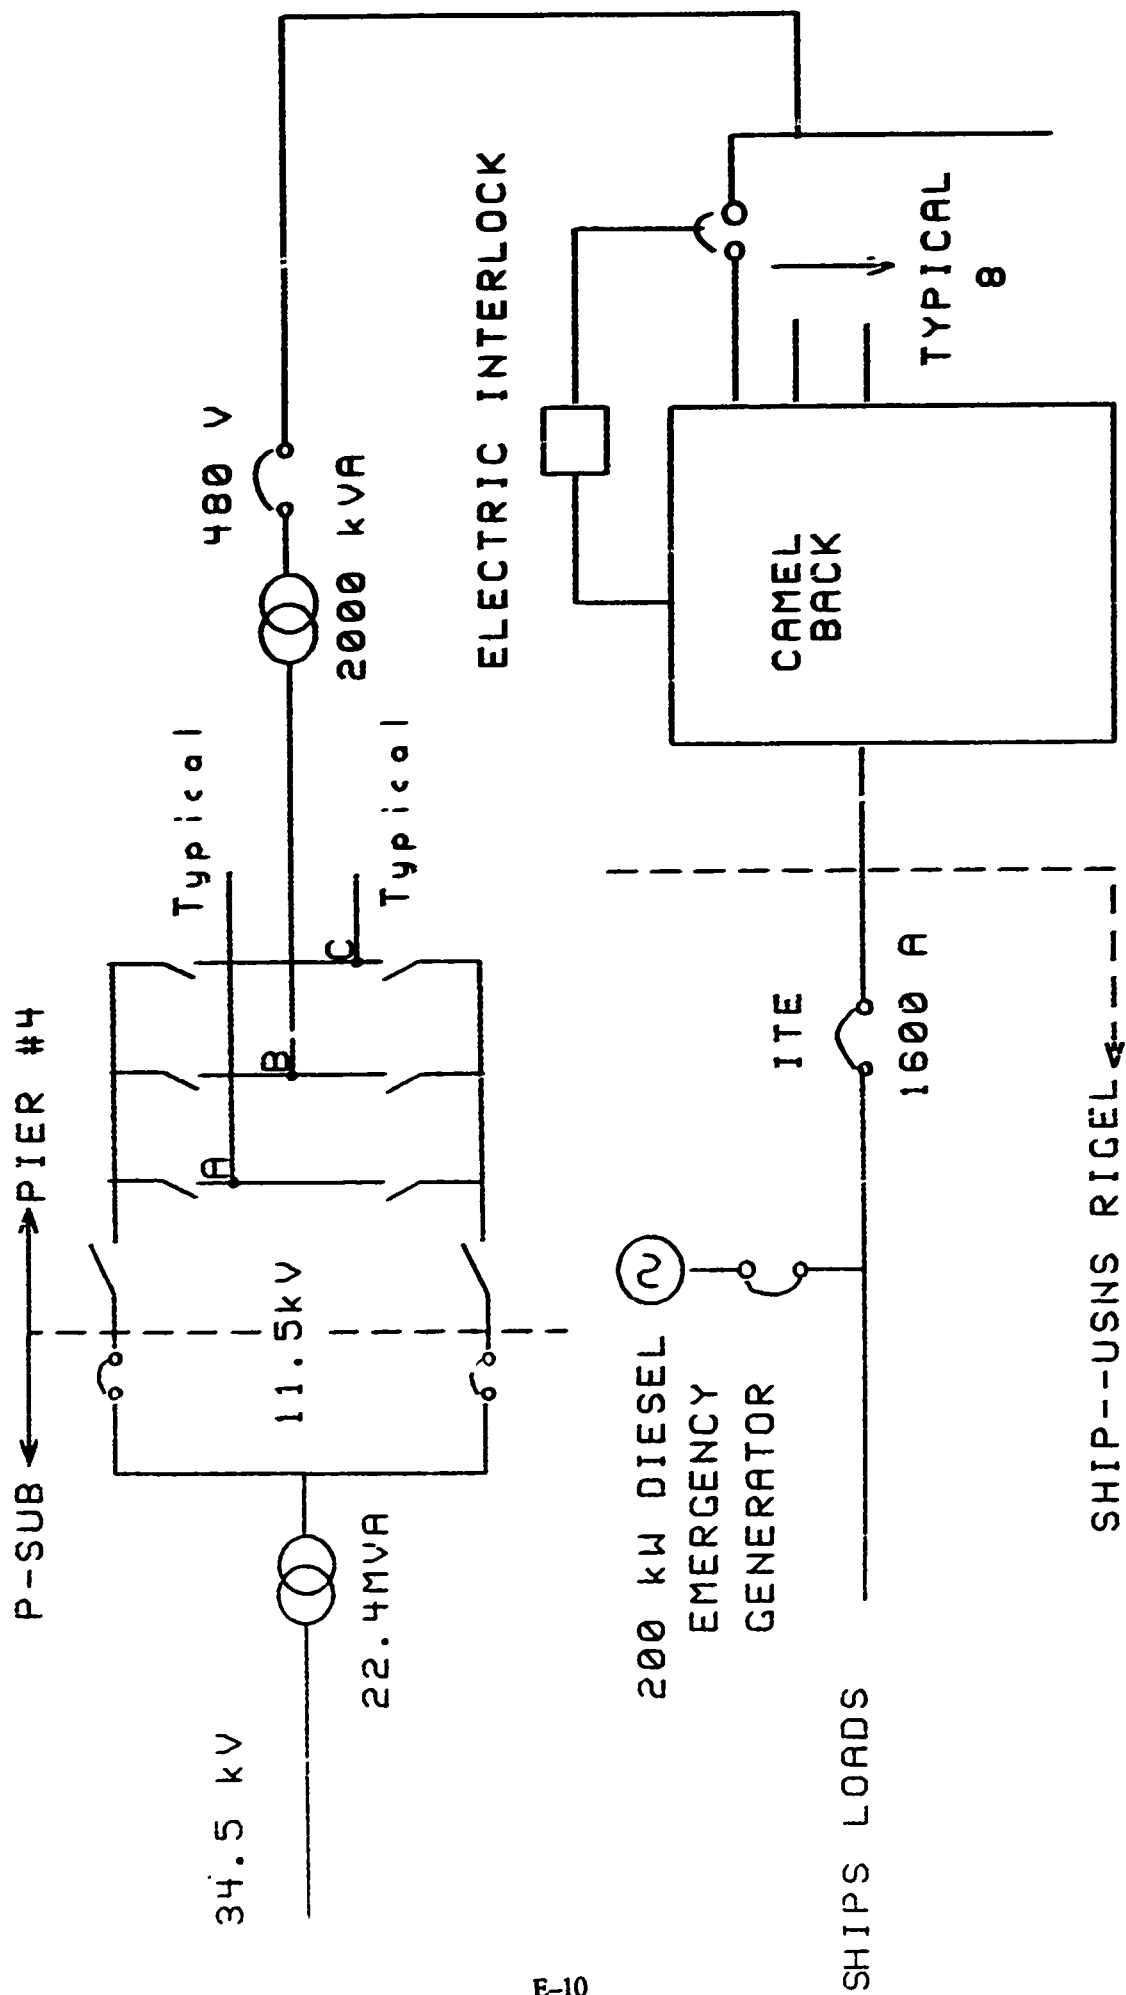
System One-Line Diagram.

The two adjacent coil assemblies were damaged by the heat and fame, but the damage was not as significant as that on the faulted coil. The fault continued for a substantial amount of time before the primary protection cleared. Estimates of the fault duration are vague and contradictory but most likely is 2 hours or more based upon the magnitude of heat damage.

After the primary protection cleared the fault, the ships 200 kW emergency generator was brought on line. Refer to the one-line diagram on the following page. The operator experienced difficulty in getting the voltage to stabilize and eventually the generator's breaker tripped off line. The operator then began to shed unnecessary loads to reduce the load level on the generator. The problem still existed and at that point it was determined that the shore to ship power feed had not been disconnected as is required. It has been estimated that approximately 30 minutes passed before the shore power cables were disconnected from the USNS Rigel. Therefore, the USNS Rigel provided both heat and arcing directly to the fault and sustained the fire for an additional 30 minutes.
